*Complete Closure and
Remediation of the
Gyöngyösoroszi Lead-Zinc
Mine*

8th July 2005

Complete Remediation of the Gyöngyösoroszi Ore Mining

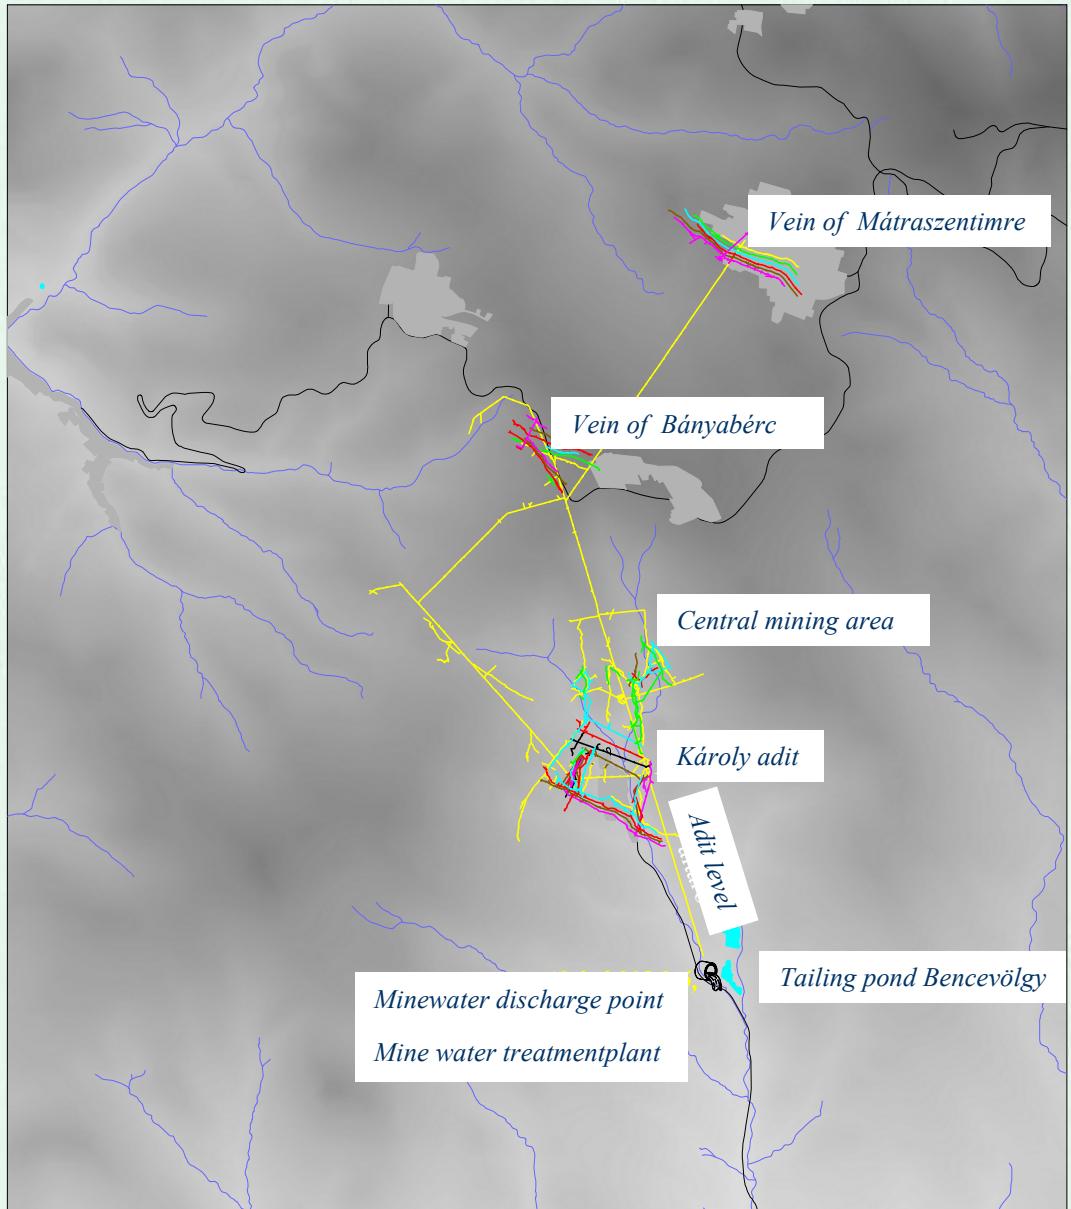
Main objects of the mine

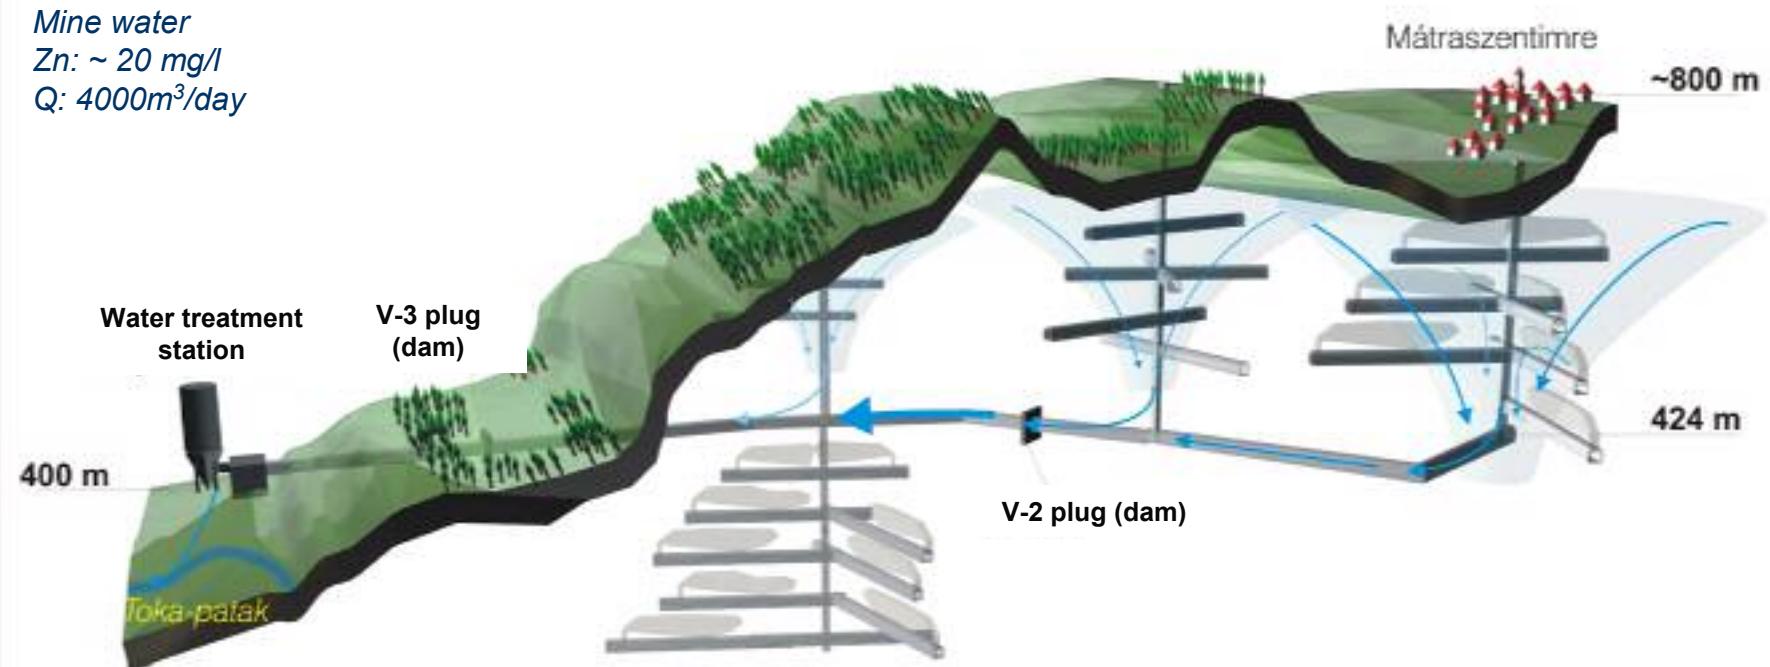
Conception of the mine closing

Recent state

Mine water
Zn: ~ 20 mg/l
Q: 4000m³/day

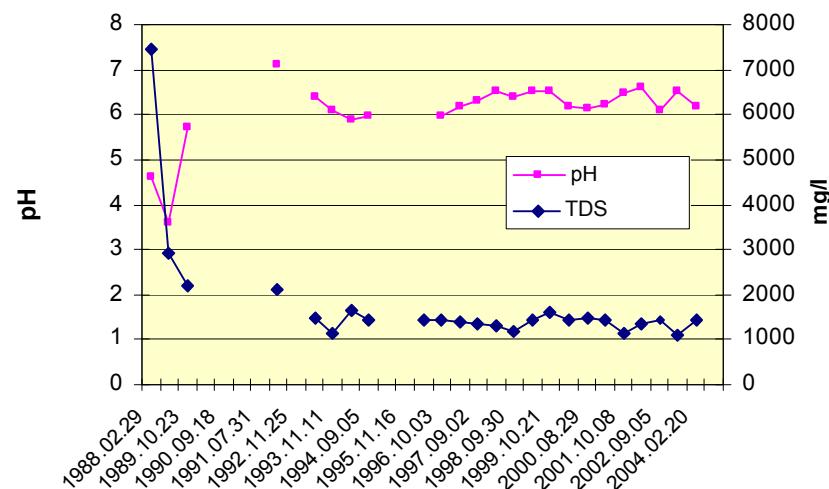
pH and TDS of the mine water between 1988-2004

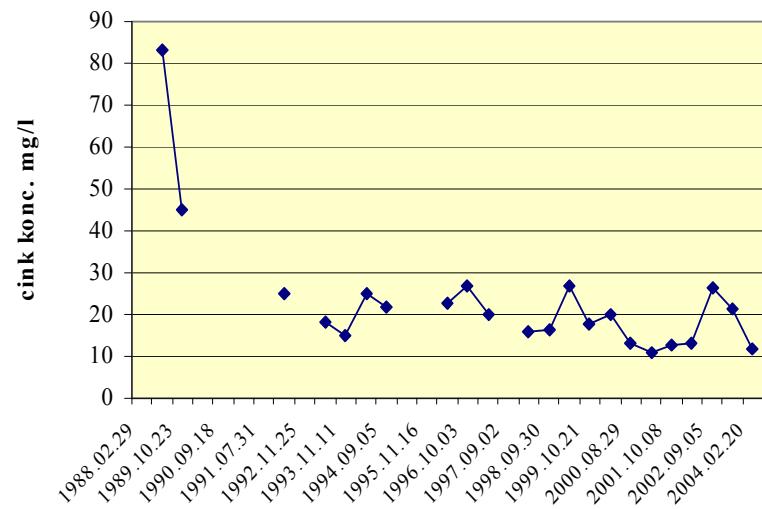
Zn concentration in mine water at discharge

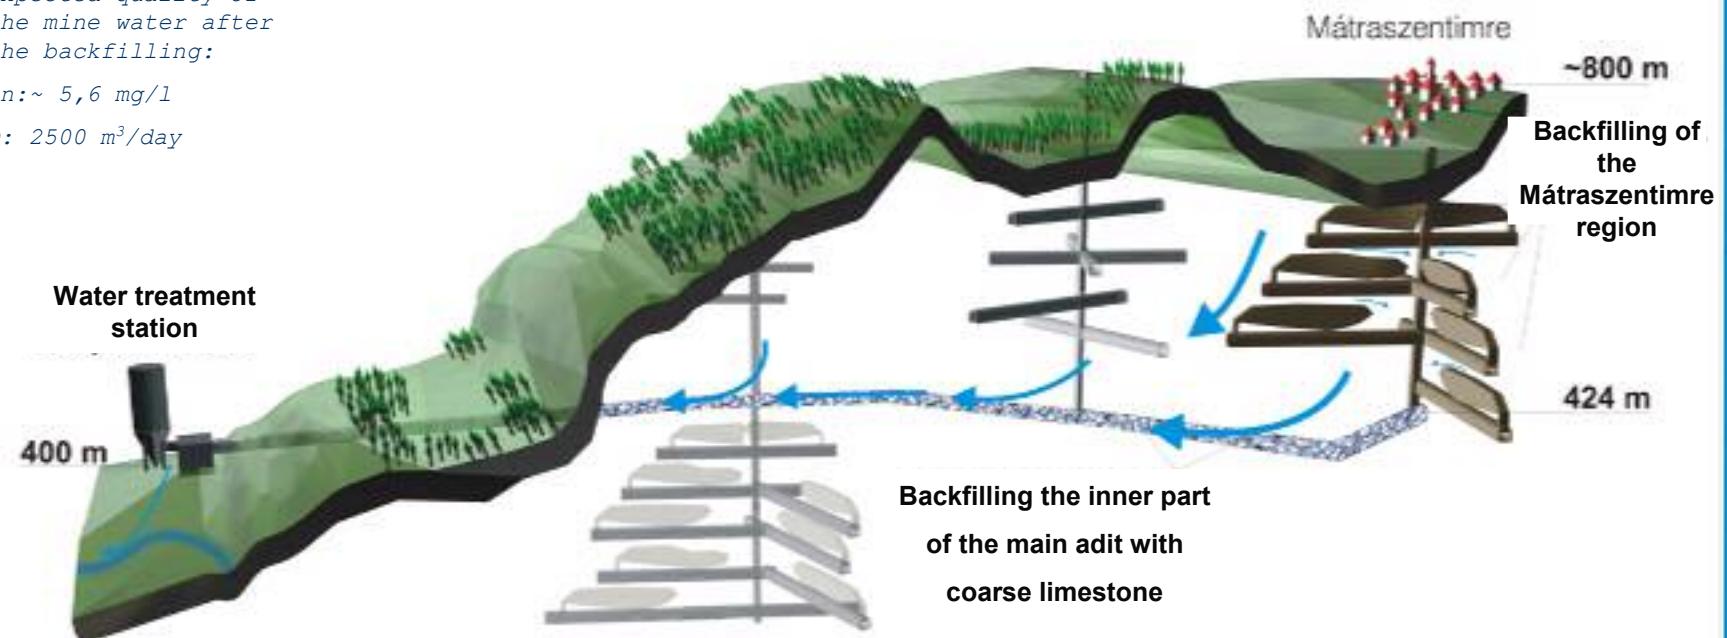
Conception of the mine closing

Expected quality of
the mine water after
the backfilling:

Zn: ~ 5,6 mg/l

Q: 2500 m³/day

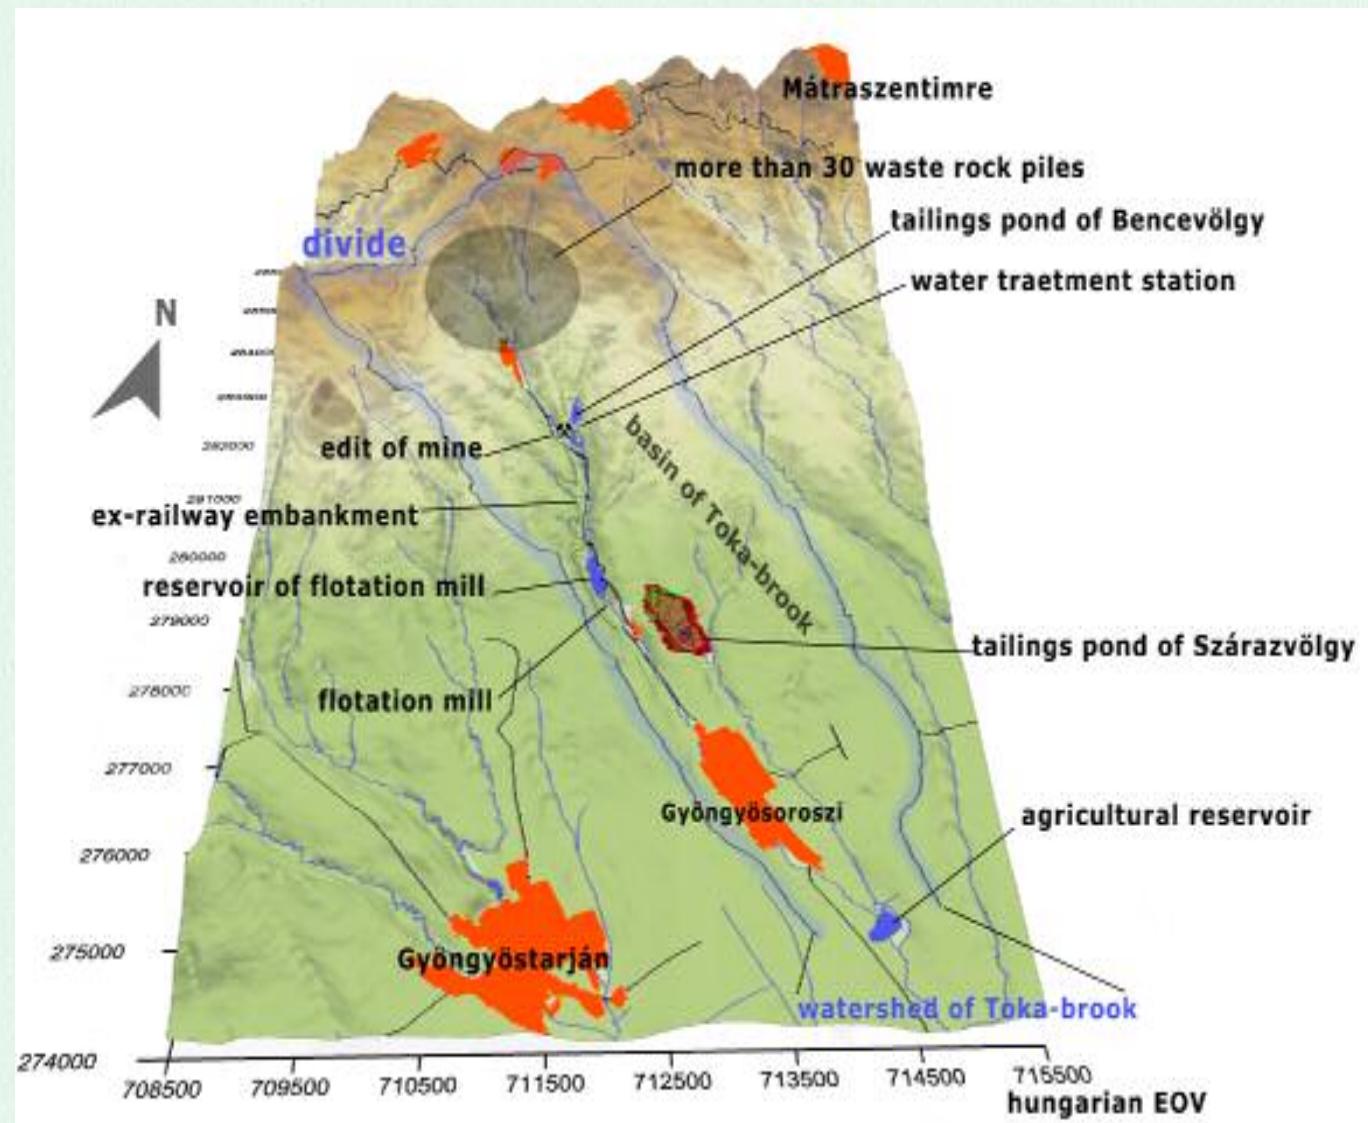
Pollution sources on the surface

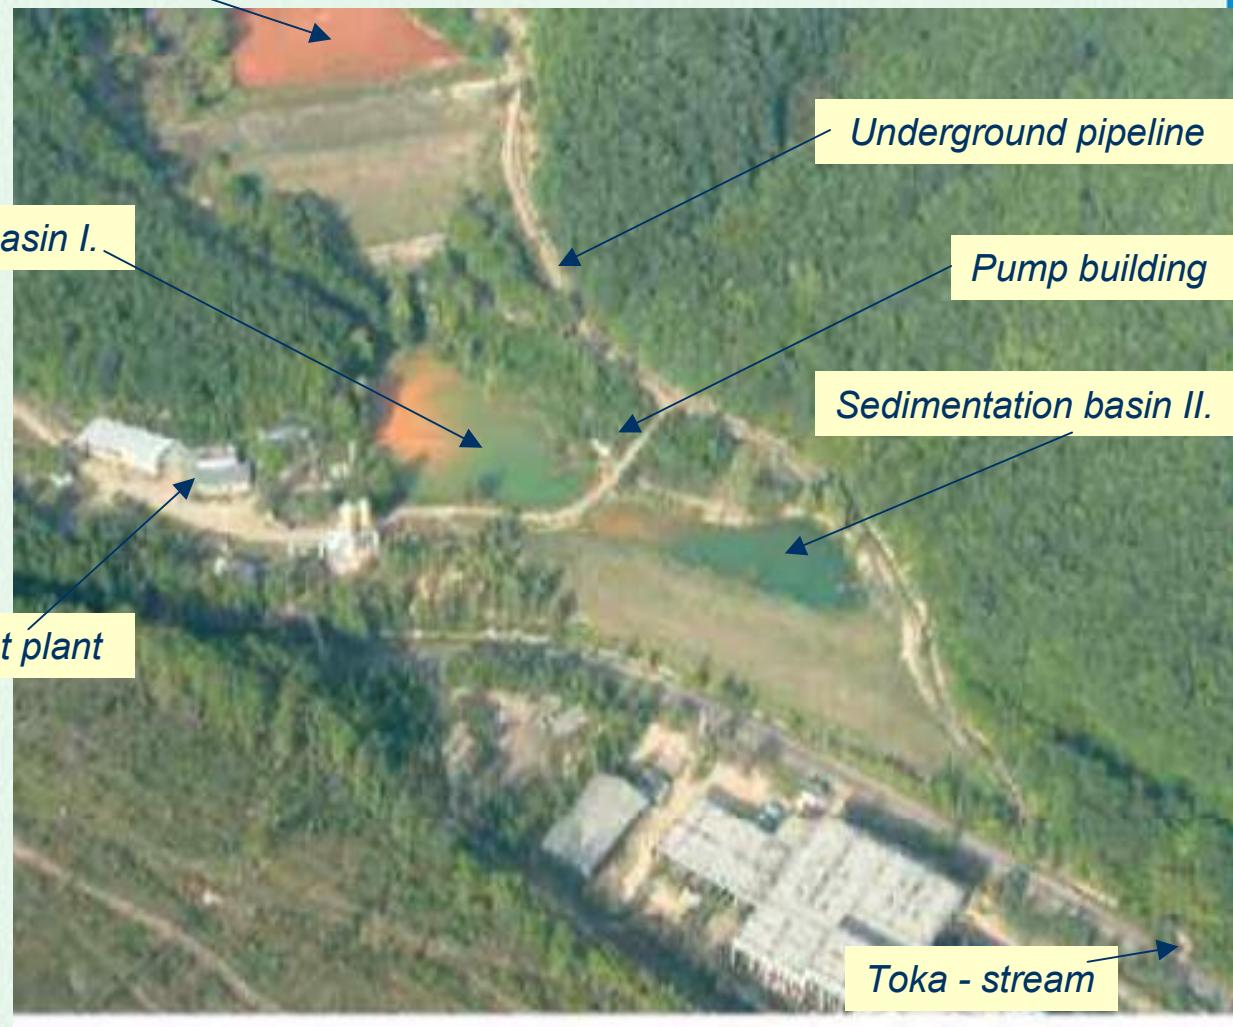
Tailing pond
Bencevölgy

Recent state

Sedimentation basin I.

Water treatment plant

Underground pipeline

Pump building

Sedimentation basin II.

Toka - stream

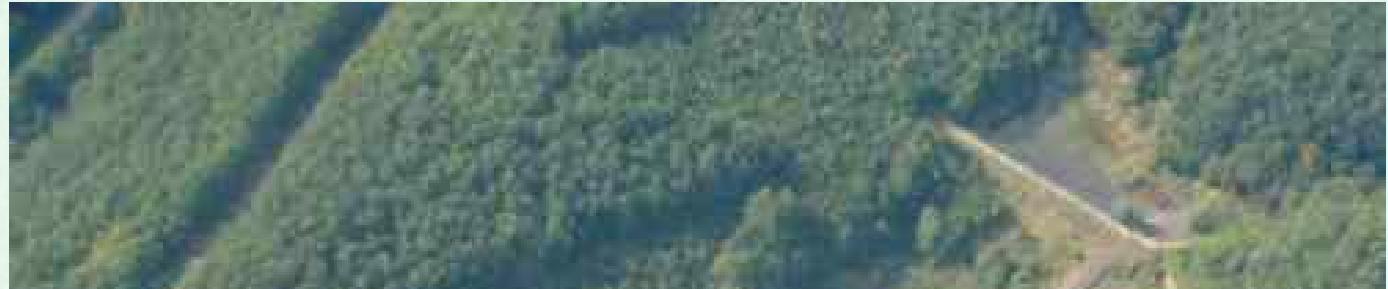
Tailings pond Bencevölgy

- 150 000 – 190 000 m³ water slurry
- 6 – 10 % total solid
- Non appropriate protection
- High contamination hazard

Average chemical composition of water slurry

- Taking-up water slurry
- Dewatering slurry
- Transportation to hazardous waste repository
- Remediation
- Deadline: 31st December 2006

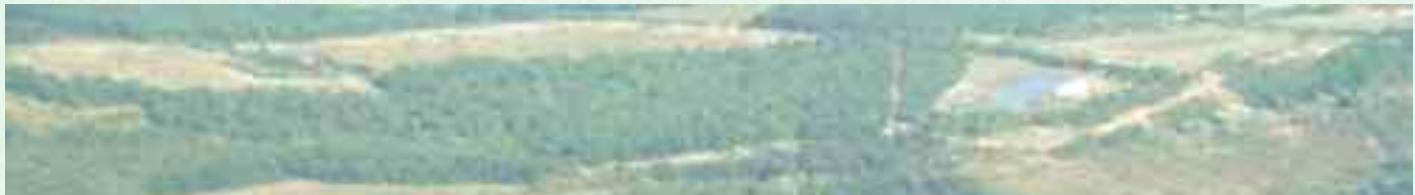
Reservoir of flotation mill

- 182 000 m³ water
- 39 000 – 40 000 m³ sludge
- Extremely high Cd concentration
- Non appropriate protection
- High contamination hazard

Average chemical composition of sludge

- Taking-up sludge
- Dewatering sludge
- Transportation to tailings pond of Szárazvölgy
- Remediation
- Save the lake as a recreation area

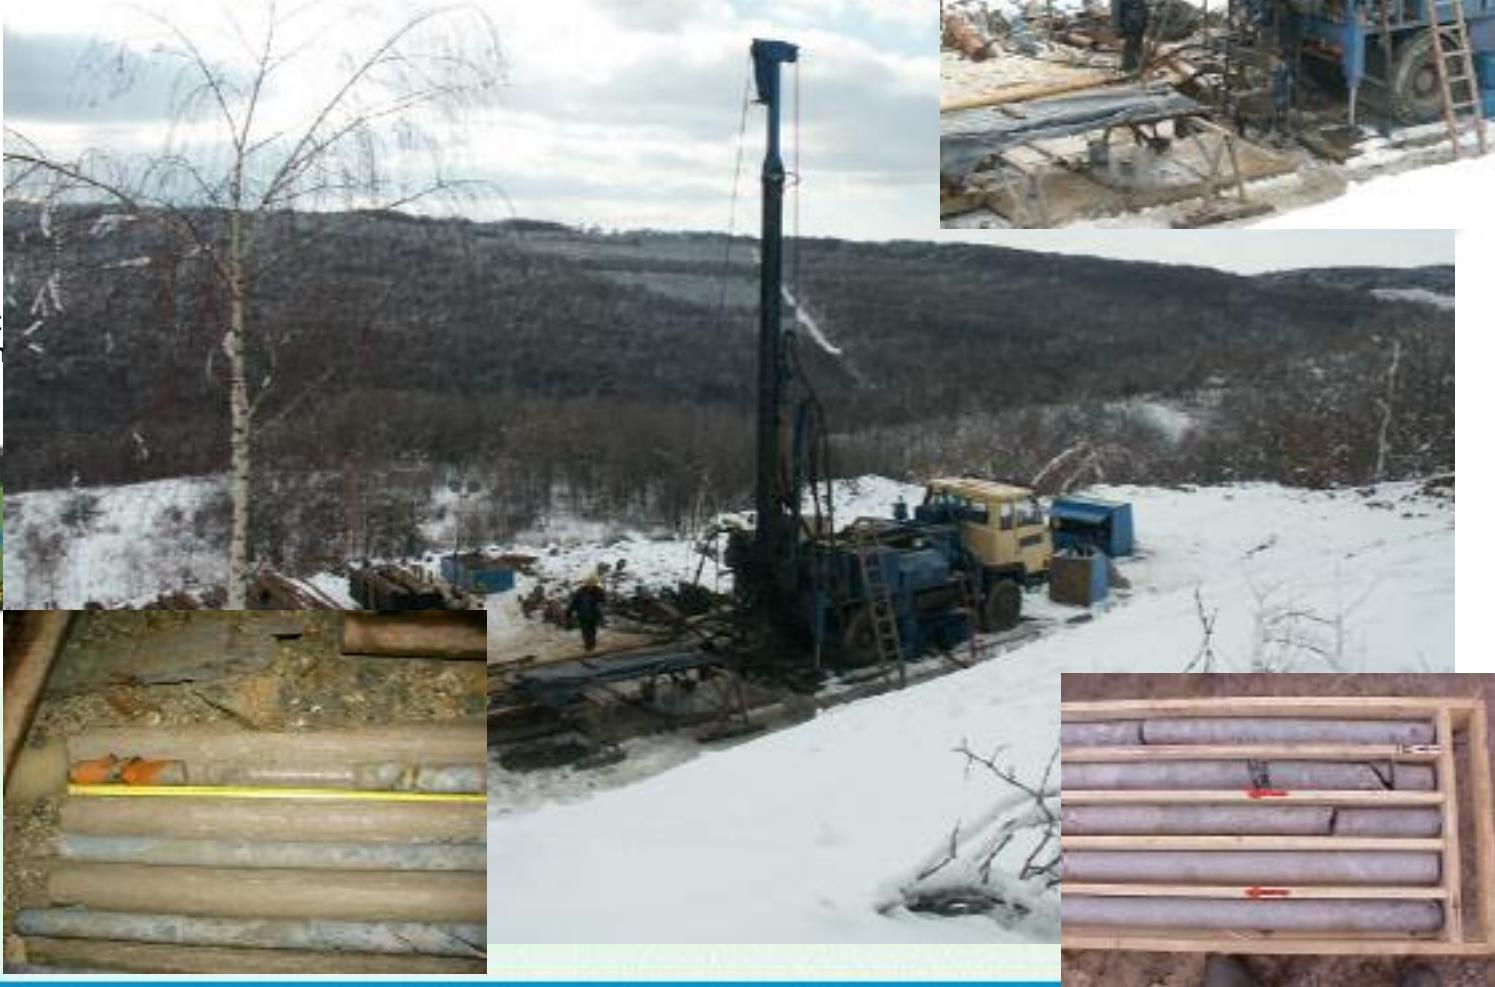
Drilling of monitoring wells Mszi-1, Mszi-1/1

- Target area: mining cavities at 424 asl
- measuring potentiometric water level during mine closing

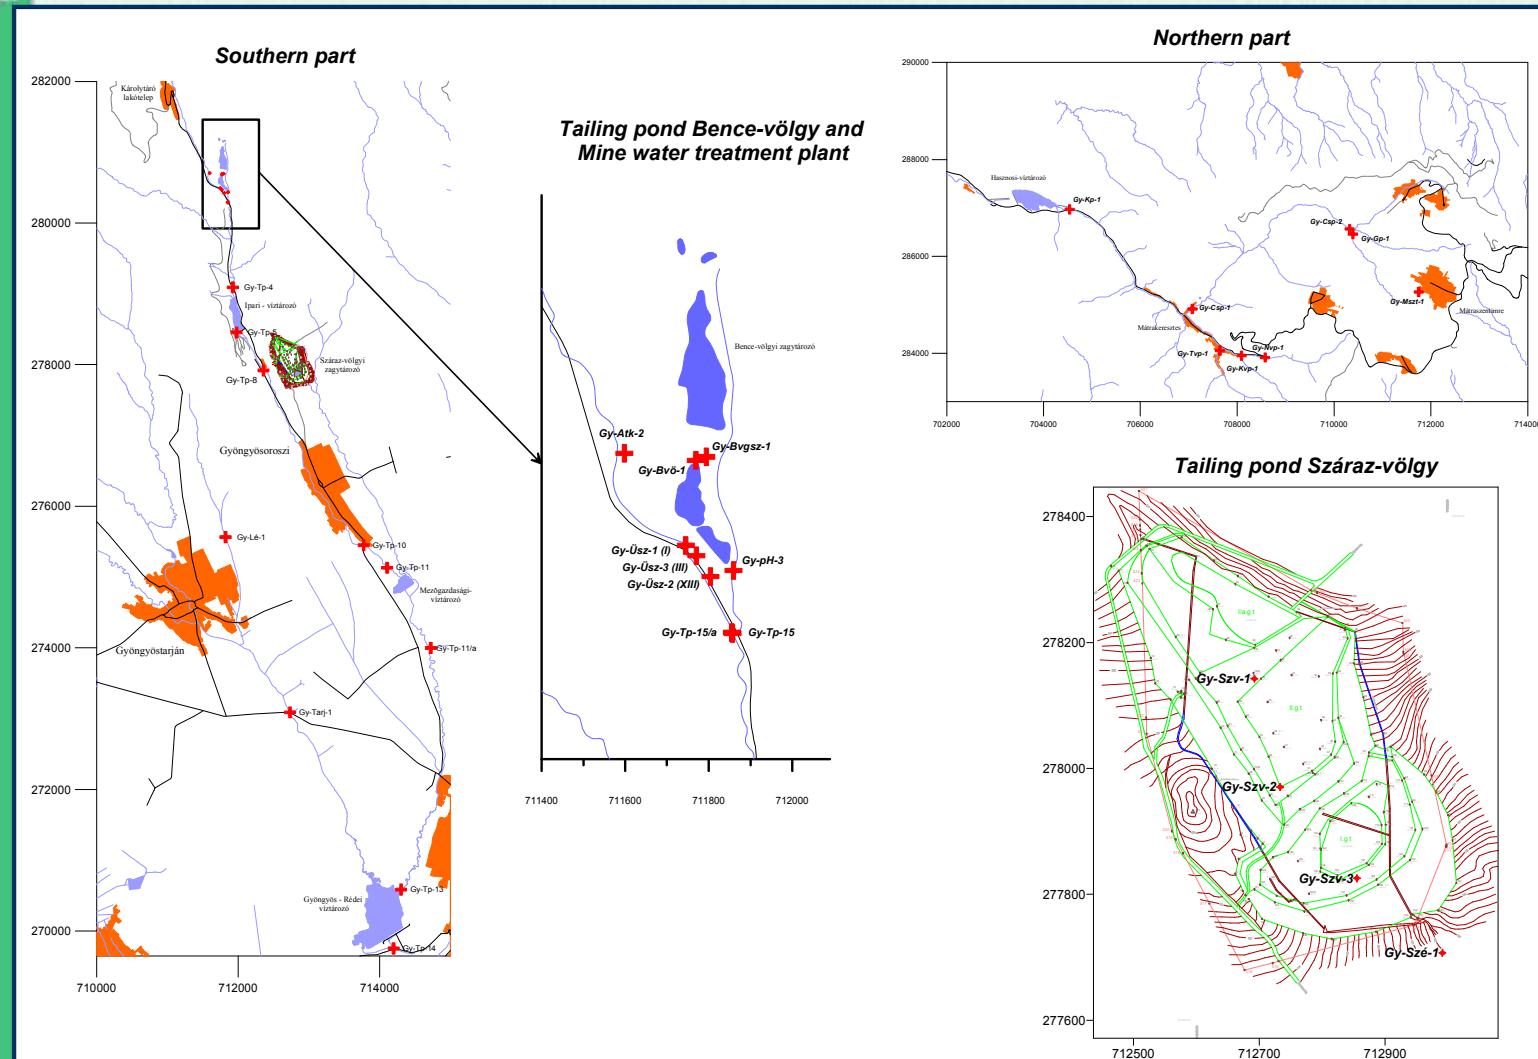
Hydrogeological monitoring objects
